A Special Solenoid Cap
By Richard R. Vensel

Watch out for this solenoid cap.

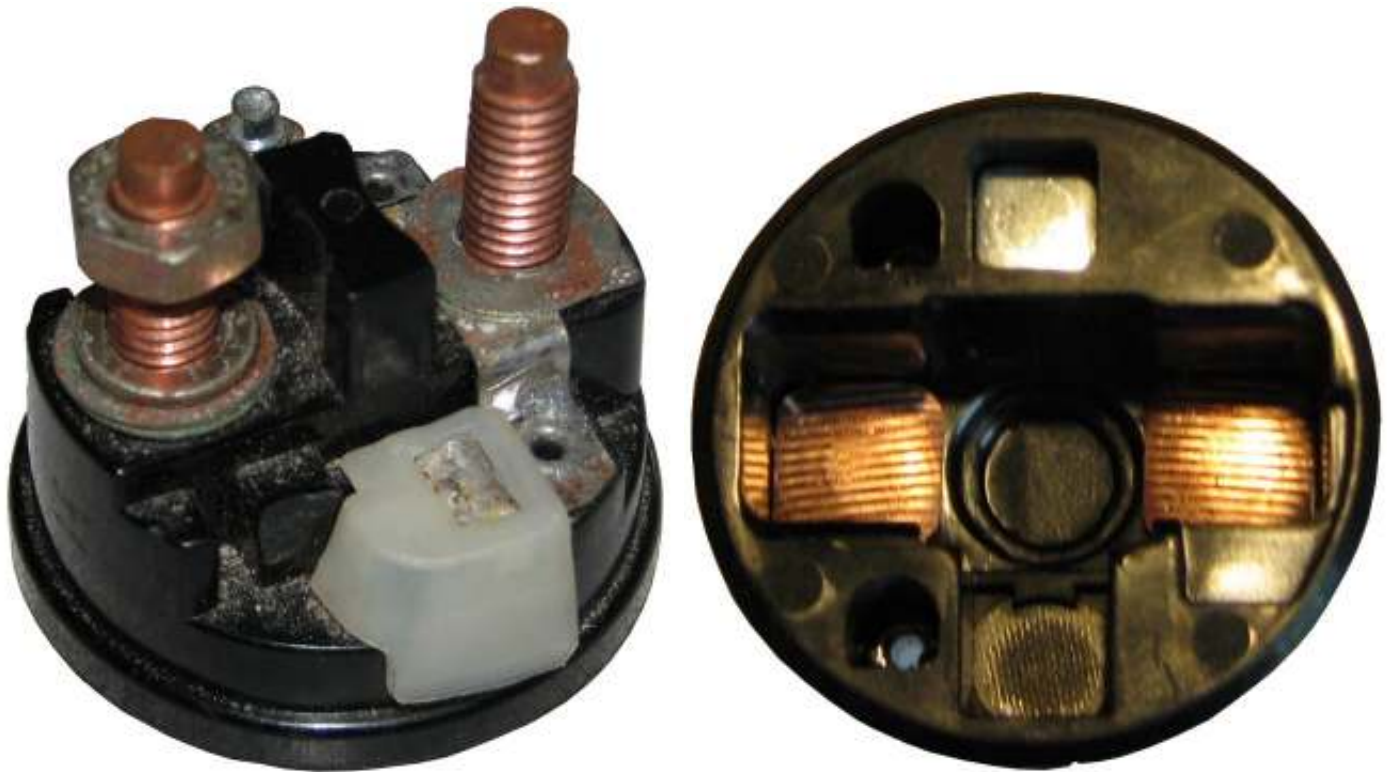
If you rebuild or repair solenoids save this picture and watch out for this one.

This is from a late Delco starter and the white plastic cover (breather cap) on the left side is covering a breathing hole (screw covered). Delco put this cap there to solve a problem such as moisture buildup/sweating. You should always replace this solenoid cap with a like cap or rework the old one. We recommend that you always use an OEM design in this application. If you rework the old one, make sure the screen is thoroughly cleaned and blown dry. This little thing can make a big difference in preventing premature failures in the field.
